INDOOR AIR QUALITY ASSESSMENT

**EOHHS Service Center
300 Howard Street
Framingham, Massachusetts**

Prepared by:
Massachusetts Department of Public Health
Bureau of Environmental Health
Indoor Air Quality Program
January 2017

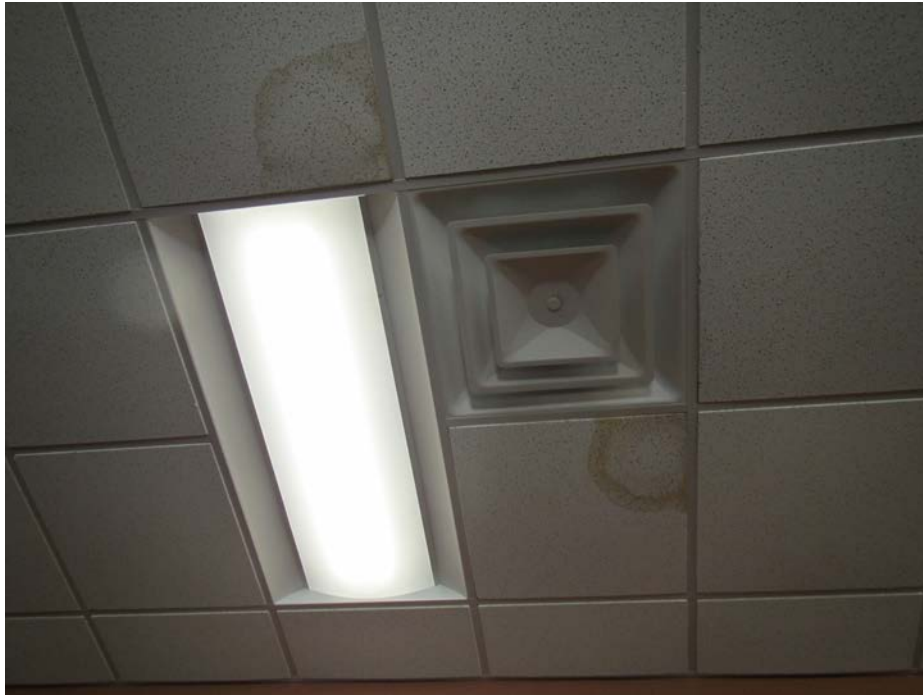
Picture 1

Fresh air is provided by air handling units (AHUs) located on the roof. Air from the AHUs is filtered, heated/cooled, and delivered to rooms via ducted supply vents (Picture 1). Air is returned/exhausted through ducted return vents (Picture 2). It is recommended that HVAC systems be re-balanced every five years to ensure adequate air systems function (SMACNA, 1994).

Water-damaged and some obviously wet ceiling tiles were observed in many places on the second floor (Table 1; Pictures 1, 4 and 5). These indicate that the roof has leaked, which has been an ongoing problem since the offices were occupied. Examination of the roof revealed that parts of the roof have subsided below the level of the roof drains which allows water to pool (Picture 6) and eventually penetrate through seams or holes in the roof. Holes in the roof should be repaired as they are discovered, and consideration should be given to a more thorough repair of the roof, including slope and drains. All leaks should be reported to building management as soon as they are discovered, and water-damaged ceiling tiles should be removed and replaced. If areas have chronic leaks, temporary use of special ceiling tile inserts that can capture and direct water via a hose into a container to reduce the chance of water damage to building materials and furnishings. The containers need to be monitored and emptied at least daily.

Supply vent, note water-damaged ceiling tiles

6. Use a reporting system to ensure that water-damaged and wet ceiling tiles and other leaks are reported promptly and removed/repaired.
7. Avoid storing materials in areas with chronic leaks. Consider the use of ceiling-tile replacements to catch leaks and drain them through a hose to a container of an appropriate volume. If used, the container must be monitored and emptied daily and kept clean to avoid odors.

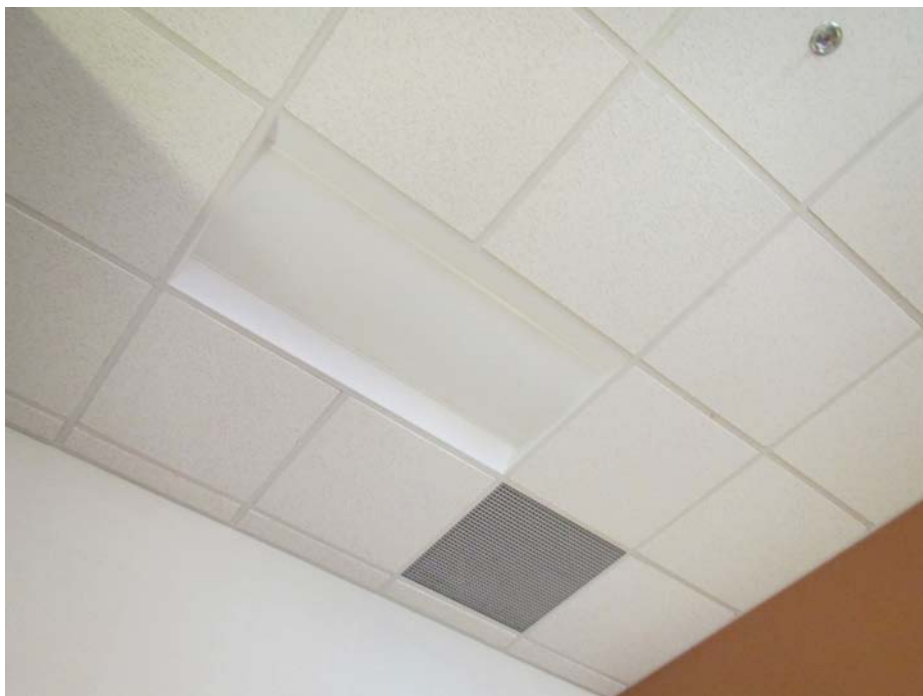
Picture 2

Return vent

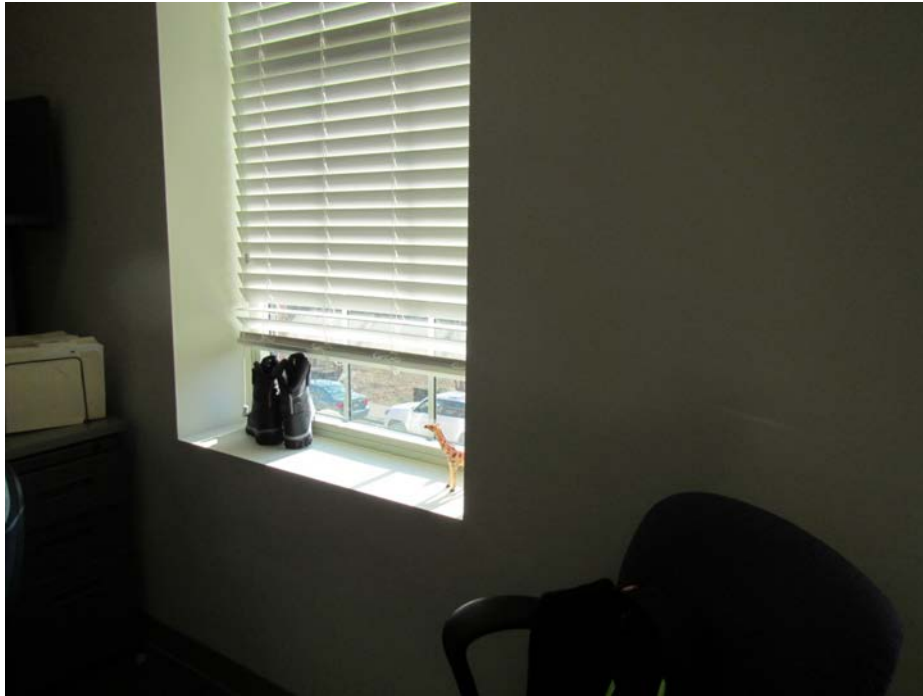
Picture 3

Along one side of the building, sunlight could be seen streaming in through the windows (Picture 3). Adjustable blinds should be used to control solar gain within the occupied space and assist with temperature control as well as reducing glare.

Items were observed on many windowsills in the office, including some that are subject to direct sunlight (Picture 3). Items containing plastic, cardboard, or inks/paints may release odors and VOCs when heated; these items should not be placed in direct sunlight.

Sunlight through window, note plastic items on windowsill

4. Use blinds to reduce solar heating and glare. Avoid storing items on windowsills that may emit odors and VOCs when heated.
5. For buildings in New England, periods of low relative humidity during the winter are often unavoidable. Therefore, scrupulous cleaning practices should be adopted to minimize common indoor air contaminants whose irritant effects can be enhanced when the relative humidity is low. To control for dusts, a high efficiency particulate arrestance (HEPA) filter equipped vacuum cleaner in conjunction with wet wiping of all surfaces is recommended. Avoid the use of feather dusters. Drinking water during the day can help ease some symptoms associated with a dry environment (throat and sinus irritations).

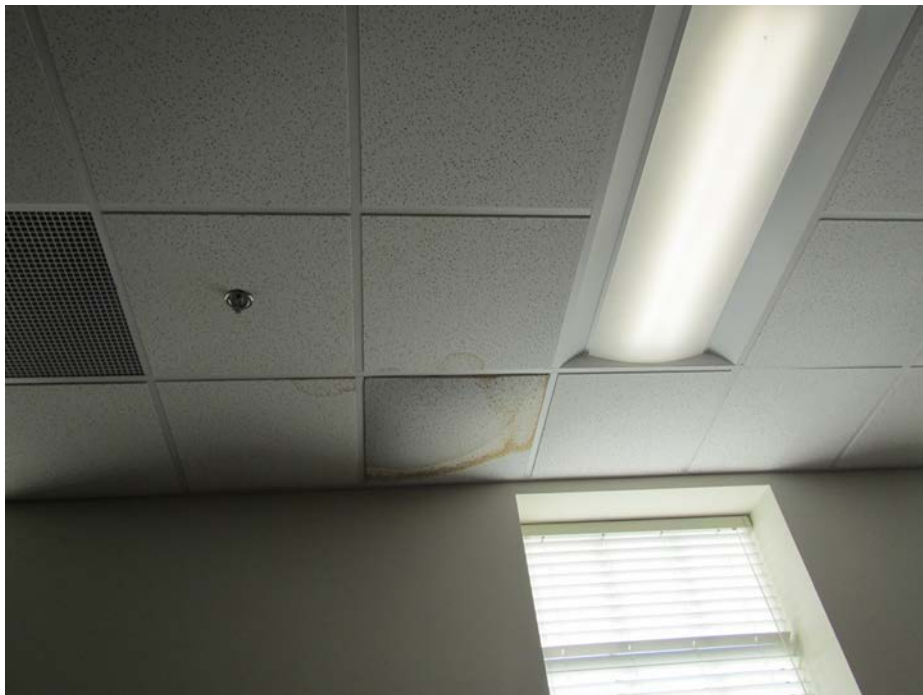
Picture 4

Wet, bulging ceiling tile

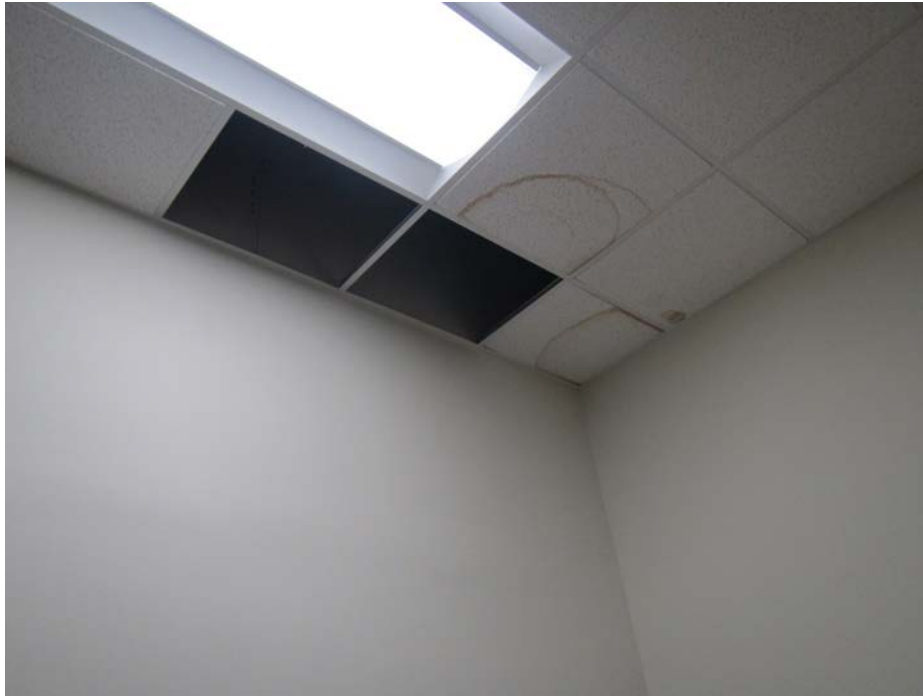
Picture 5

Water-damaged and missing ceiling tiles

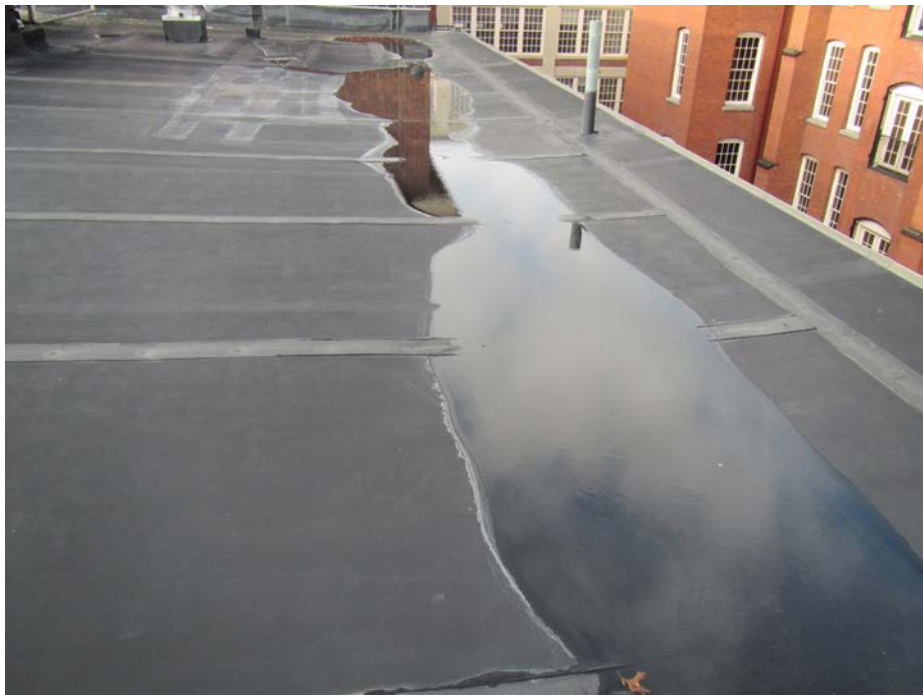
Picture 6

Water pooling on the roof due to poor slope to roof drains

8. Have the roof patched as needed. Consider undertaking a complete overhaul of the roof including ensuring roof drains can function properly.
9. Keep indoor plants in good condition, avoid overwatering, and avoid placing them on porous items such as carpets or paper. Also, keep plants out of the air stream of supply vents.

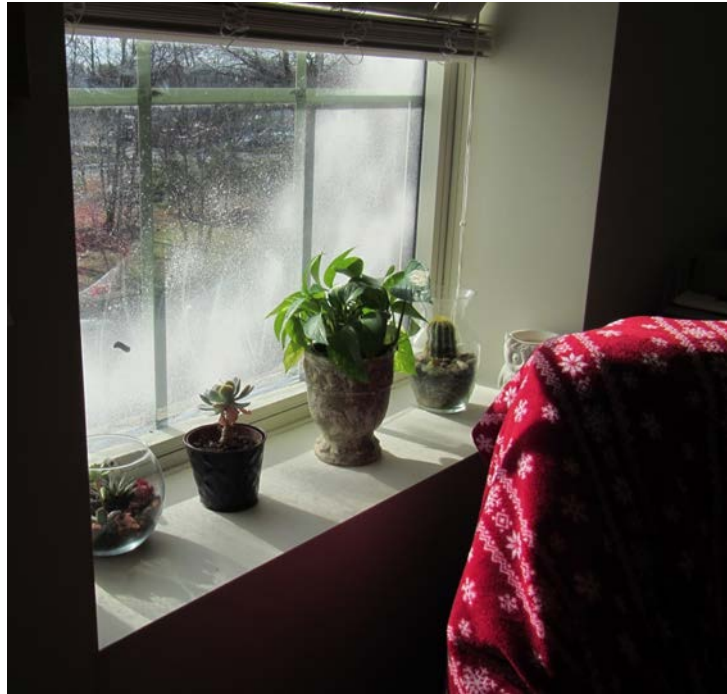
Picture 7

Plants were observed in office areas (Table 1; Picture 7). Plants can be a source of pollen and mold, which can be respiratory irritants to some individuals. Plants should be properly maintained and equipped with drip pans to prevent water damage to porous materials. Plants should also be located away from air diffusers to prevent the aerosolization of dirt, pollen, and mold.

Plants on a windowsill

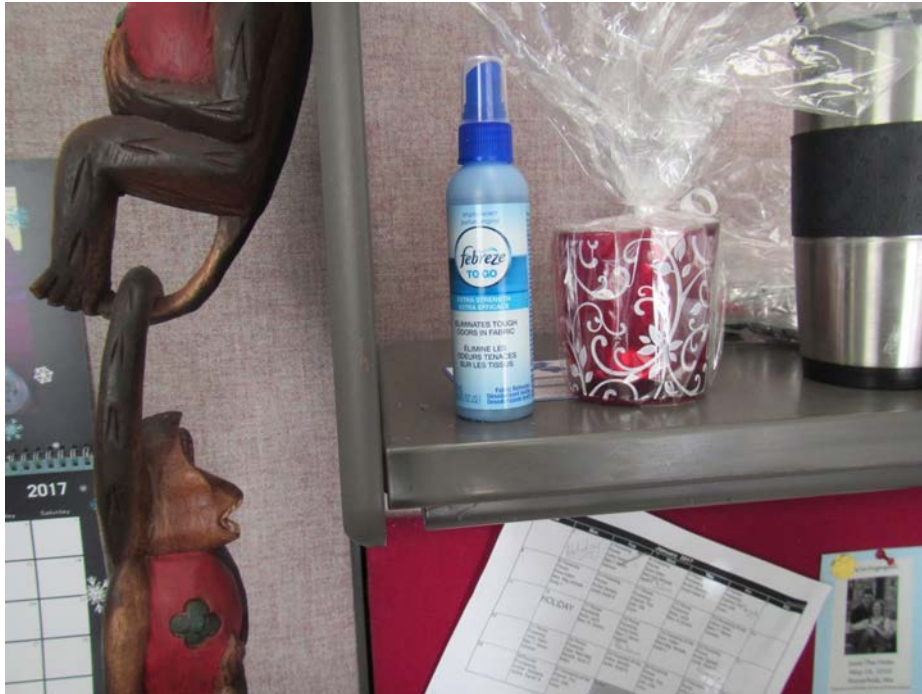
Picture 9

Exposure to low levels of total volatile organic compounds (TVOCs) may produce eye, nose, throat, and/or respiratory irritation in some sensitive individuals. BEH/IAQ staff examined rooms for products containing VOCs. BEH/IAQ staff noted hand sanitizers, cleaners, air freshener products, and dry erase materials in use within the building (Pictures 8 and 9; Table 1). All of these products have the potential to be irritants to the eyes, nose, throat, and respiratory system of sensitive individuals.

Air freshener/cleaner

11. Reduce use of products containing VOCs including eliminating air freshening products.
12. Ensure cooking areas/equipment are kept clean to prevent odors and pests. Consider reducing the number of areas where food is stored and locating them away from occupied areas.

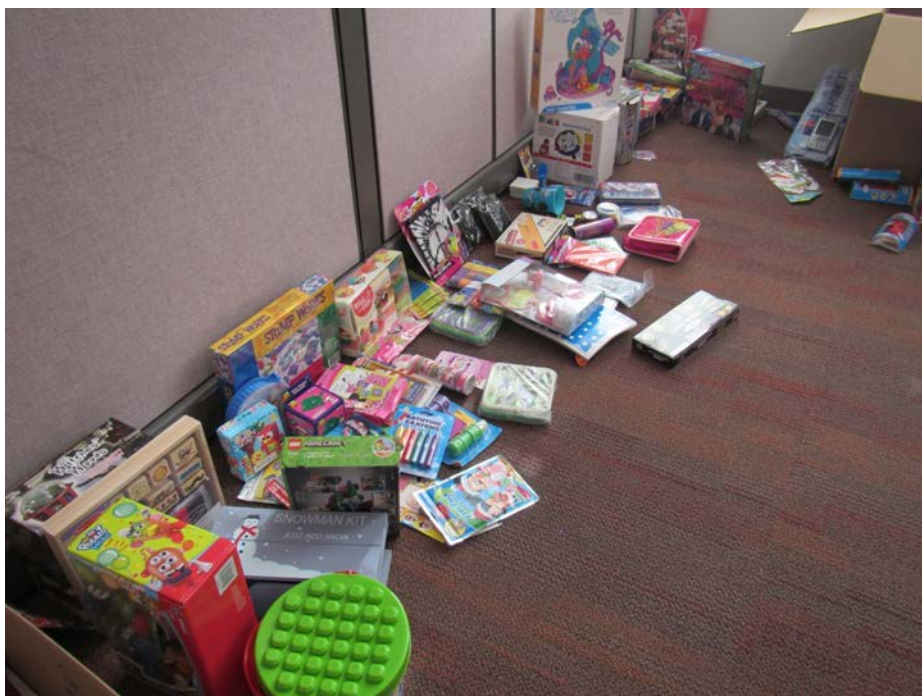
Picture 10

In some areas, stored materials and accumulated items make it more difficult for custodial staff to clean. Items for clients, such as clothing and toys, were stored in the open in some areas (Picture 10) which can allow for dusts to accumulate, create harborage for pests, or allow for hidden water damage when leaks occur. Items should be stored neatly, preferably on shelves or in closable bins, and moved periodically to allow for wet wiping and vacuuming of surfaces.

Toys stored on the floor in piles

14. Reduce accumulated materials on flat surfaces and move periodically to allow for thorough cleaning.
15. Store items for clients such as clothing and toys in an organized manner, preferably in closed totes or on shelves to prevent dust accumulation and reduce harborage for pests.

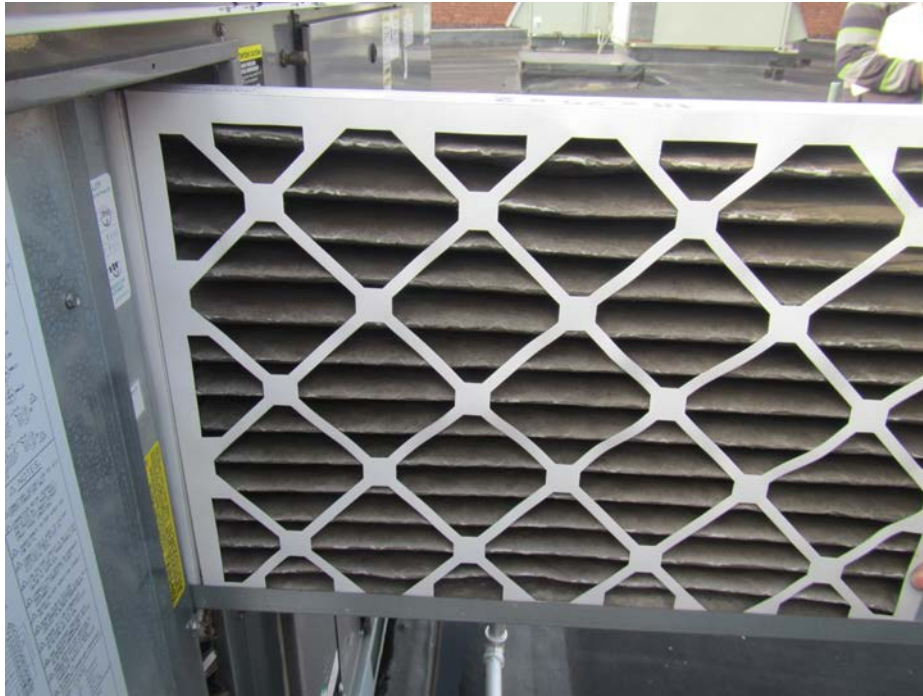
Picture 11

The rooftop AHU for Section 4 on the second floor was opened and examined. The filter was soiled and in need of changing (Picture 11). It could not be determined at what frequency the filters were currently being changed. Filters in the AHUs should be changed no less frequently than twice a year; if filters are significantly soiled when they are changed, the frequency should

be increased. A log of when filters are changed should be kept for reference and to ensure these goals are met. Filters should be of a pleated type with a Minimum Efficiency Reporting Value (MERV) of 8 or better, and should fit flush into the AHU cabinets without gaps.

Soiled AHU filter

3. Ensure filters are changed in all AHU a minimum of twice a year, more frequently if filters are significantly soiled between changes. A log should be kept of filter changes to ensure this occurs. Filters with a MERV value of 8 or higher that properly fit the AHUs should be used.

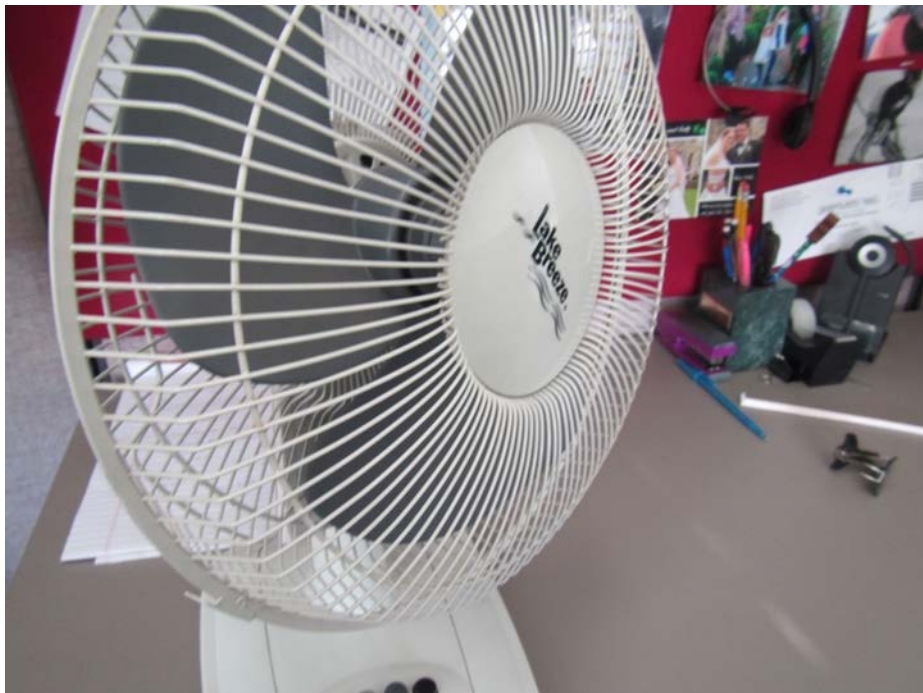
Picture 12

Personal fans were observed in a number of areas (Table 1; Picture 11). Fan blades to some of these units had settled dust, which can be reaerosolized when the fan is activated.

Dusty personal fan

16. Avoid hanging items from the ceiling tiles to avoid create dust and allowing debris from above the ceiling tiles into occupied spaces.
17. Clean the blades of personal fans, supply, and exhaust vents periodically to avoid aerosolizing dusts.
